## PHASE I ENVIRONMENTAL SITE ASSESSMENT (ESA)

ABANDONED RAILROAD EASEMENT
BETWEEN KIHEKAH AND LYNN, AND 5<sup>TH</sup> STREET AND 3<sup>RD</sup> STREET/BIRD CREEK
CITY OF PAWHUSKA, OSAGE COUNTY, OKLAHOMA

MARCH 19, 2009

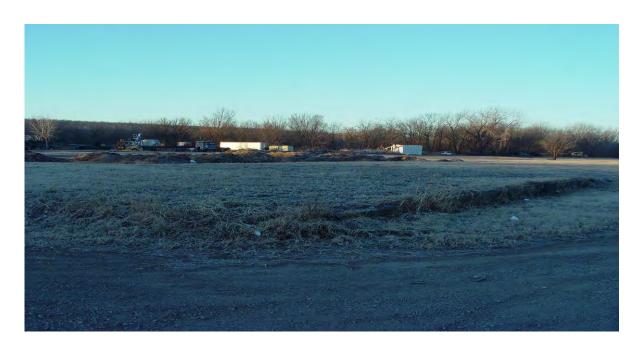
Photograph 5. Looking southwest at the concrete footing at the eastern portion of the Site.

- 3. Concrete piles and old concrete building footings are scattered throughout the Site. It is recommended that the concrete be removed prior to any redevelopment of the Site.

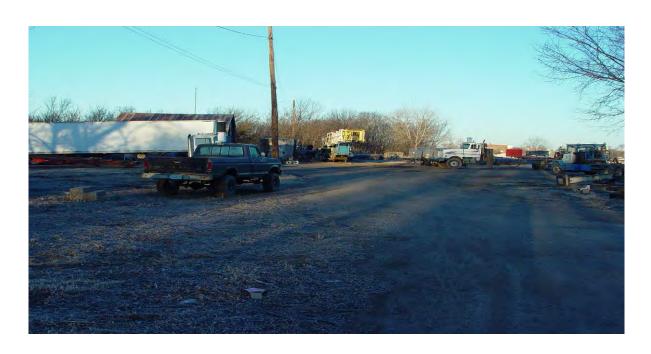
Photograph 8. General site conditions at Milleson Oilfield Service, looking west from the southeast corner of the Site.

- 2. *Milleson Oilfield Services*. Current usage of the Site for storing old oilfield equipment, service vehicles, and heavy equipment has likely resulted in hydrocarbon and/or metals impact to surface and subsurface soils. There is also the potential for limited low level radiological contamination due to NORM from piping and tubing formerly used for oilfield production or produced water handling operations. It is recommended that surface and subsurface sampling be conducted to determine if soils and uppermost groundwater have been impacted above any regulatory action thresholds. It is further recommended that the

- oilfield equipment and debris piles be removed from this area and either be recycled or disposed of in accordance with applicable regulations.
- 3. Former Parks Concrete Plant. Current usage of the Site for storage of old automobiles appliances, and waste oil drums has potentially resulted in hydrocarbon and/or metals impact to the surface and subsurface soils. It is recommended that surface and subsurface sampling be conducted to determine if soils and uppermost groundwater have been impacted above any regulatory action threshold. It is also recommended that the old automobiles and appliances be removed from the Site and either be recycled or disposed of in accordance with applicable regulations.

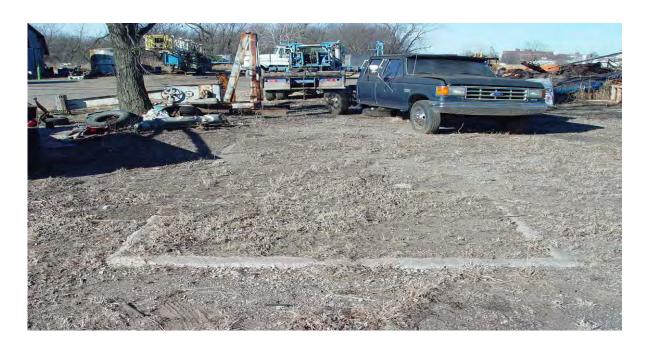
Photograph 13. Looking west at the 9'x24' concrete footing north of Milleson Oilfield Service.

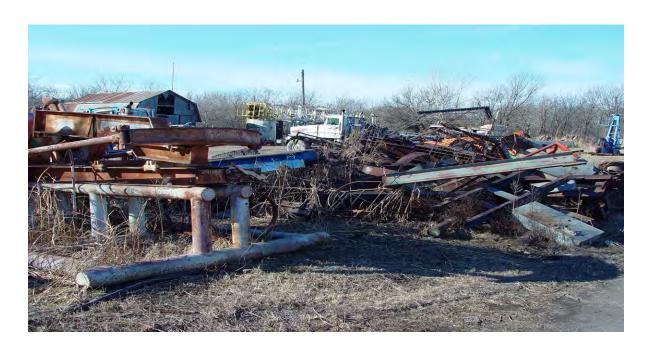
Photograph 15. Looking west at a 54'x39' pile of steel equipment near Milleson Oilfield Service.

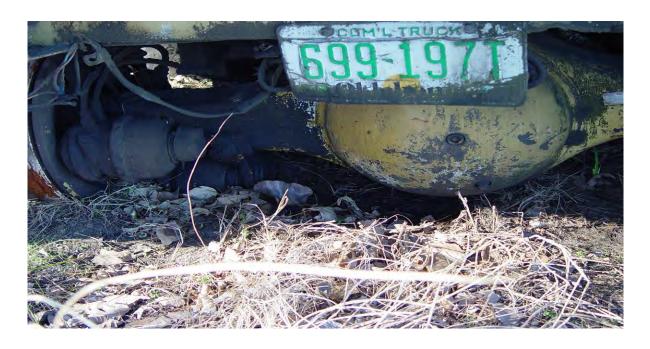
- B) Milleson Oilfield Service is located in the southeast corner of the Site. Their property consists of several sheds and office buildings, drilling rigs, trucks, and pump jacks in various states of disrepair. Several concrete pads and footings are also located near this property of which the former uses are unknown (see **Appendix D**, photos 13-21). A 54'x39' pile of discarded steel and equipment is located in the vicinity of Milleson Oilfield Service (see **Appendix D**, photos 15-17). Due to the amount of material present, soil staining underneath the pile could not be adequately observed. Dumping of scrap materials, machinery, and equipment was observed on the north bank of the river. In this same area, the oil soaked axle of a large piece of machinery was observed to be directly in contact with the ground (see **Appendix D**, photos 18-21).

Photograph 21. View of a leaking transfer case and an oil soaked axle in contact with the ground.

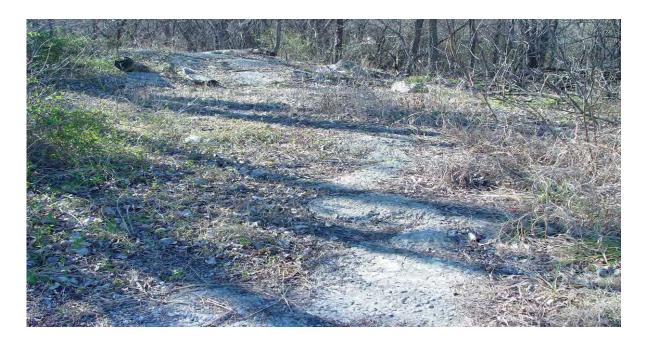
Photograph 22. Looking south at 12'x66' concrete dumpsite at the southern edge of the Site.

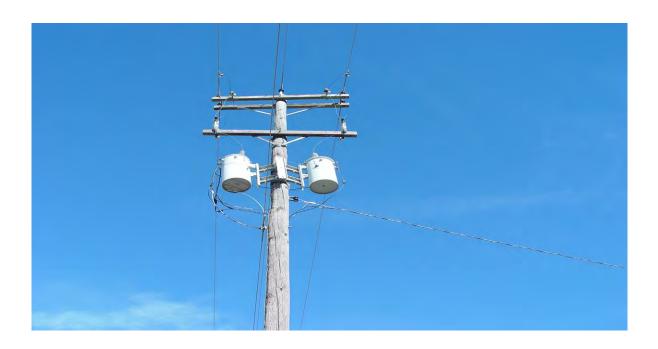
Photograph 27. Looking at 2 pole mounted transformers.

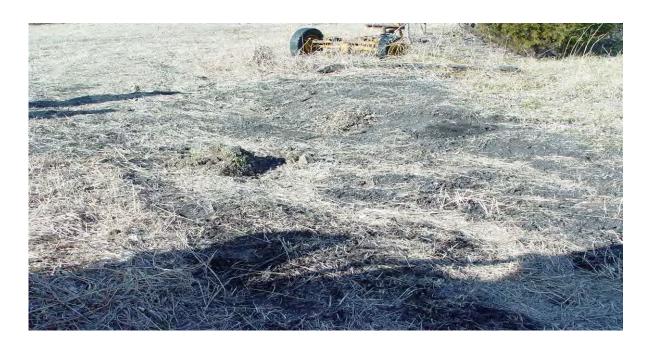
- C) Several areas containing slag, disturbed soil, and evidence of hydrocarbon presence in the soil were observed in the middle portion of the Site (see **Appendix D**, photos 24, 25, 28, 31, and 53).

Photograph 31. View of a 12'x30' area of slag.

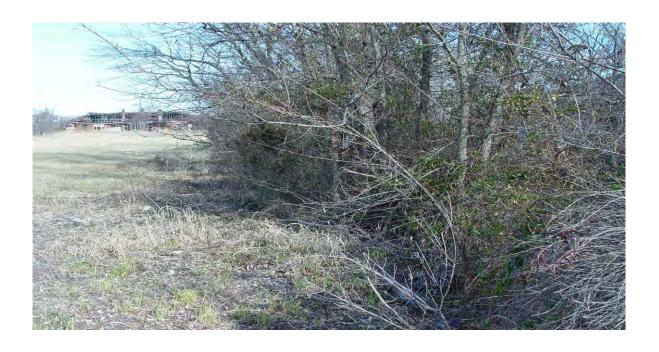
- F) A historic railroad turnaround and maintenance yard was formerly located in the southwestern portion of the Site with a railroad corridor running the length of the entire Site (see **Appendix D**, photos 32-34). Although no staining or soil disturbance observed could be directly associated with the railroad, railroad maintenance yards suggest the use of solvents and presence of metals which could adversely impact the soils of the Site.

Photograph 33. Looking north at the general site conditions of the southern portion of the mid-western edge of the site.

- 4. Former Railroad Operations. Historic usage of portions of the Site for maintenance operations, coke storage, and rail transport has likely resulted in hydrocarbon and/or metals impact to surface and subsurface soils. Additionally, an interview with a retired rail worker indicates that a customary practice of using a spray car to apply herbicides to rail lines and crossings may have led to surface and subsurface impact due to these chemicals. It is recommended that surface and subsurface sampling be conducted to determine if soils and uppermost groundwater have been impacted above any regulatory action threshold.

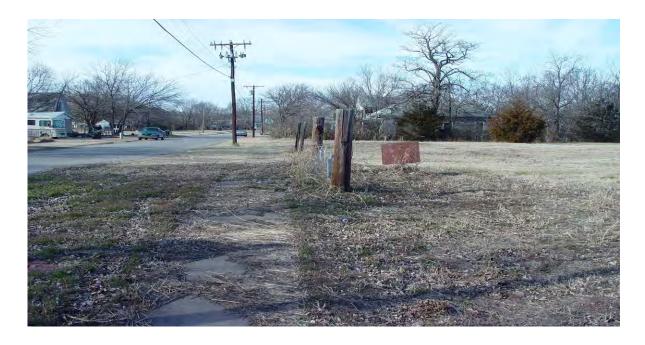
Photograph 34. Looking west at the general site conditions of the southern portion of the mid-western edge of the site.

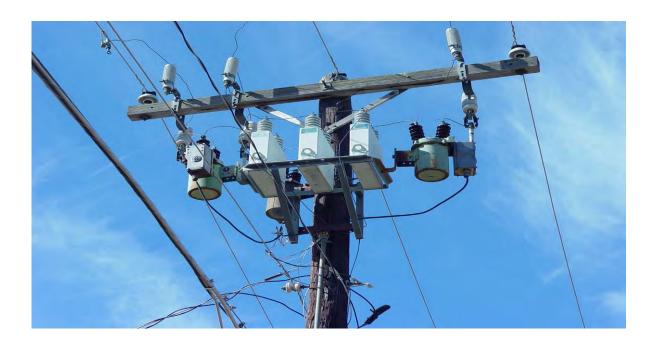
Photograph 35. View of pole mounted transformers within the Site.

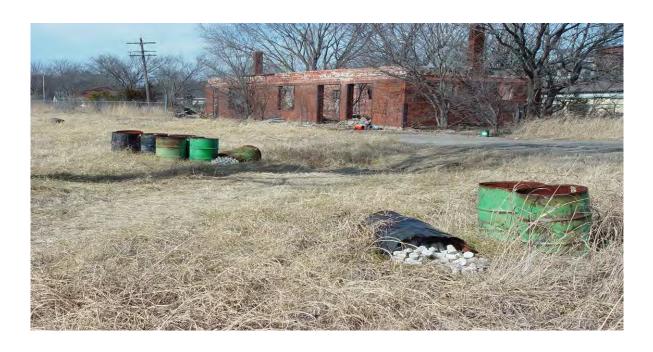
- D) Two former train depot buildings were observed within the mid-western portion of the Site. A pile of tires, 60'x60', is located on the northeast corner of the east depot building. On the south wall of the west depot building, one of three 5-gallon buckets of lubricant has been spilled and spread onto the walls and floor of the building. Nineteen 55-gallon barrels full of cement test cups were present inside and around both of the train depot buildings. The east depot building has a room which is approximately half full of trash including thousands of styrofoam cups (see **Appendix D**, photos 39, 41-47)

Photograph 41. Looking northwest at twelve, 55 gallon drums in the foreground and the west train depot building in the background.

- 5. Waste styrofoam containers and cement test plugs were observed in 55-gallon drums near and within the abandoned train depot buildings. It is recommended that these be removed and disposed in accordance with applicable regulations.
- 6. Three 5-gallon containers of lubricating grease were observed on the south side of the west abandoned train depot, and had been smeared on the depot building wall. It is recommended that the lubricating grease be removed from the Site and disposed in accordance with applicable regulations.

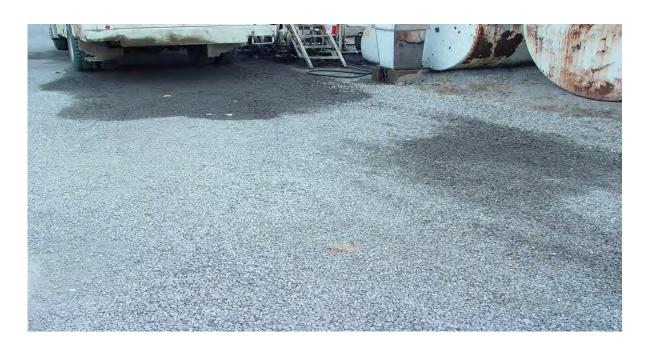
Photograph 61. Three Oil Stains near the west building of Formby Oil Company (west): 4'x8', 8'x36', and 4'x6'.

- 1. *Formby Oil Company*. Historical and current activities of this facility have likely resulted in hydrocarbon and/or metals impact to the surface and subsurface soils. It is recommended that surface and subsurface sampling be conducted to determine if soils and uppermost groundwater have been impacted above any regulatory action threshold. It is further recommended that ASTs and drums be placed within proper secondary containment and not be in direct contact with the ground surface.

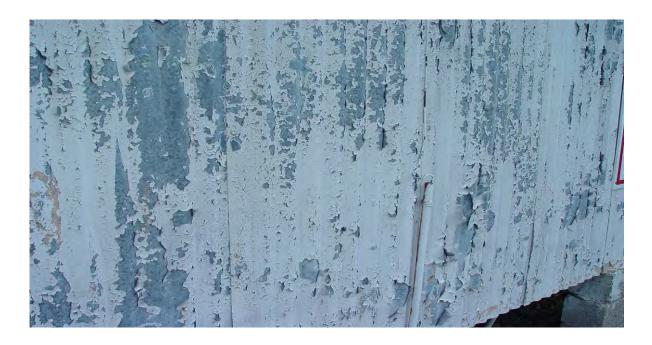
Photograph 62. Peeling paint on the Formby Oil Company building (east).

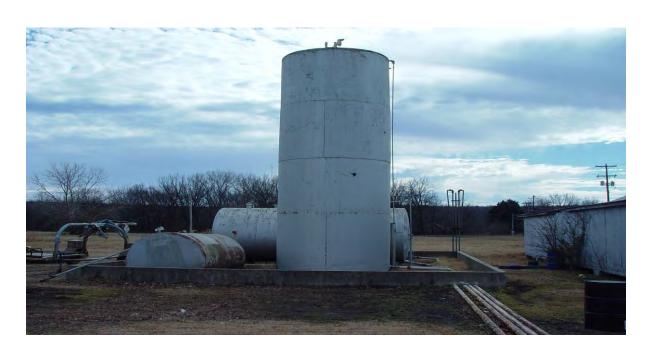
Photograph 67. Looking at three ASTs at Formby Oil Company (east).

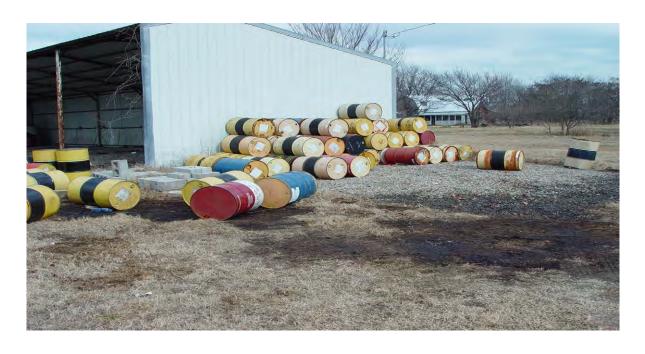
Photograph 69. View of approximately seventy five, 55 gallon drums east of Formby Oil Company (east). Note stained surface.

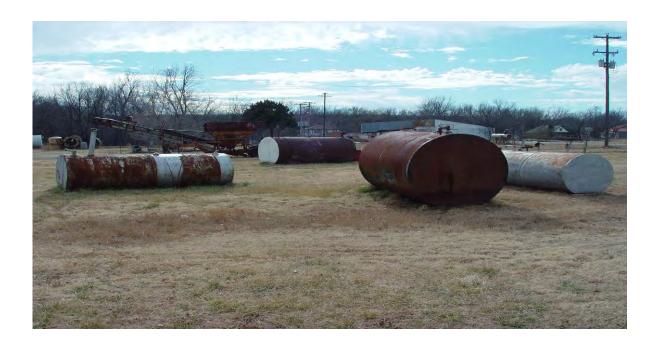
Photograph 70. View of four, approximately 4,000 gallon ASTs southeast of Formby Oil Company.

- 9. *Unregistered Aboveground Storage Tanks (ASTs)*. Records obtained from Environmental Data Resources do not identify several of the observed ASTs (central portion of Site) as being registered with the Oklahoma Corporation Commission. As such, the presence of these ASTs under an unregistered status is considered to pose a threat for environmental impact to the Site, and is therefore considered to be a REC until proven otherwise. It is recommended that, if an AST contains any free liquid, the AST contents be sampled and identified, and then disposed of according to applicable regulations. It is also recommended that soil and uppermost groundwater samples be collected to determine if any impact has occurred above any regulatory action levels. It is further recommended that these ASTs be removed from the Site and disposed of in accordance with applicable regulations.

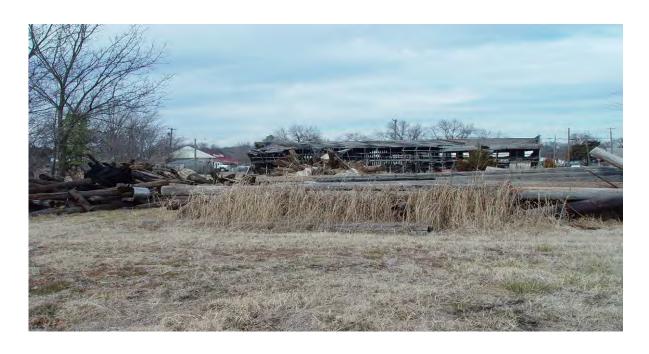
Photograph 73. Looking at a 70'x60' pile of telephone poles and concrete rubble.

- 10. *Telephone Pole Storage*. Current usage of the north central portion of Site for storage of telephone poles by the City of Pawhuska has potentially resulted in impact to the surface soils from wood preservatives. It is recommended that surface and subsurface sampling be conducted to determine if soils and uppermost groundwater have been impacted above any regulatory action threshold.

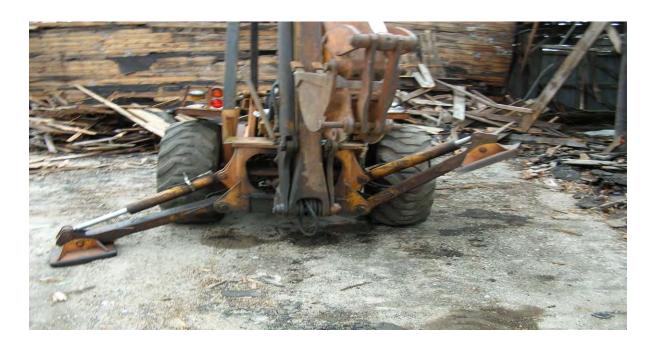
Photograph 85. View of a backhoe inside the east portion of partially collapsed Osage Building Materials warehouse building with visible staining on the ground.

- 11. *Osage Building Materials Warehouse.* Due to the age of construction, it is likely that this building may contain asbestos containing building materials. It is recommended that an asbestos inspection be conducted by a licensed asbestos inspector to determine if asbestos containing materials are present. It is further recommended that the containers of floor wax and old automobiles be removed from the Site and disposed of in accordance with applicable regulations.
